# Analysis on the mechanical properties of historical brick masonry after machinery demolition

Deniz Ucer<sup>a,\*</sup>, Aleksey Ulybin<sup>b</sup>, Sergey Zubkov<sup>b</sup>, Soofia Tahira Elias-Ozkan<sup>a</sup>

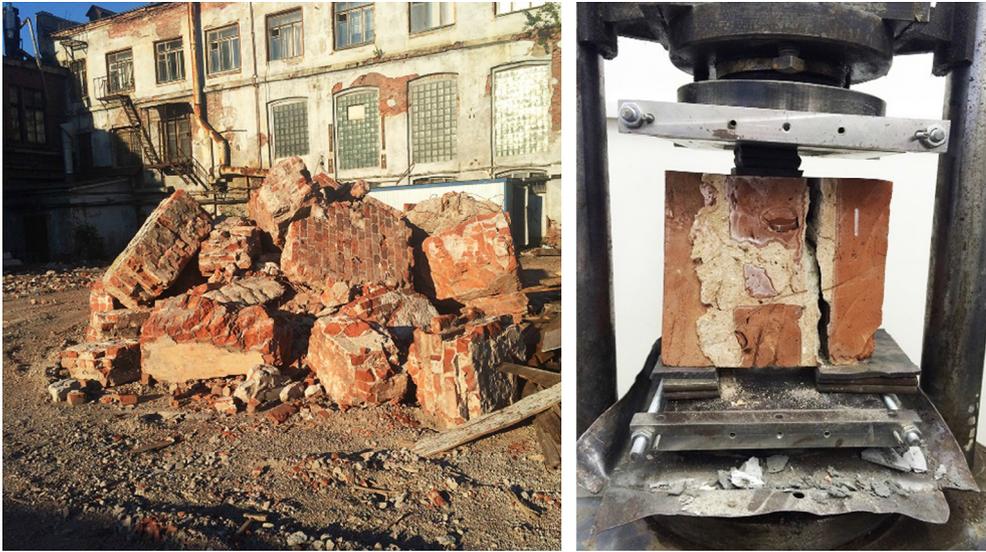
Fig. 1. The process of the study: investigation into the properties of debris, laboratory tests.

This paper is based on information gathered from a case study regarding a demolition project and tests conducted on the physical properties of the demolition debris collected from the site (Fig. 1). The focus of the study was on the end-of-life scenarios of masonry

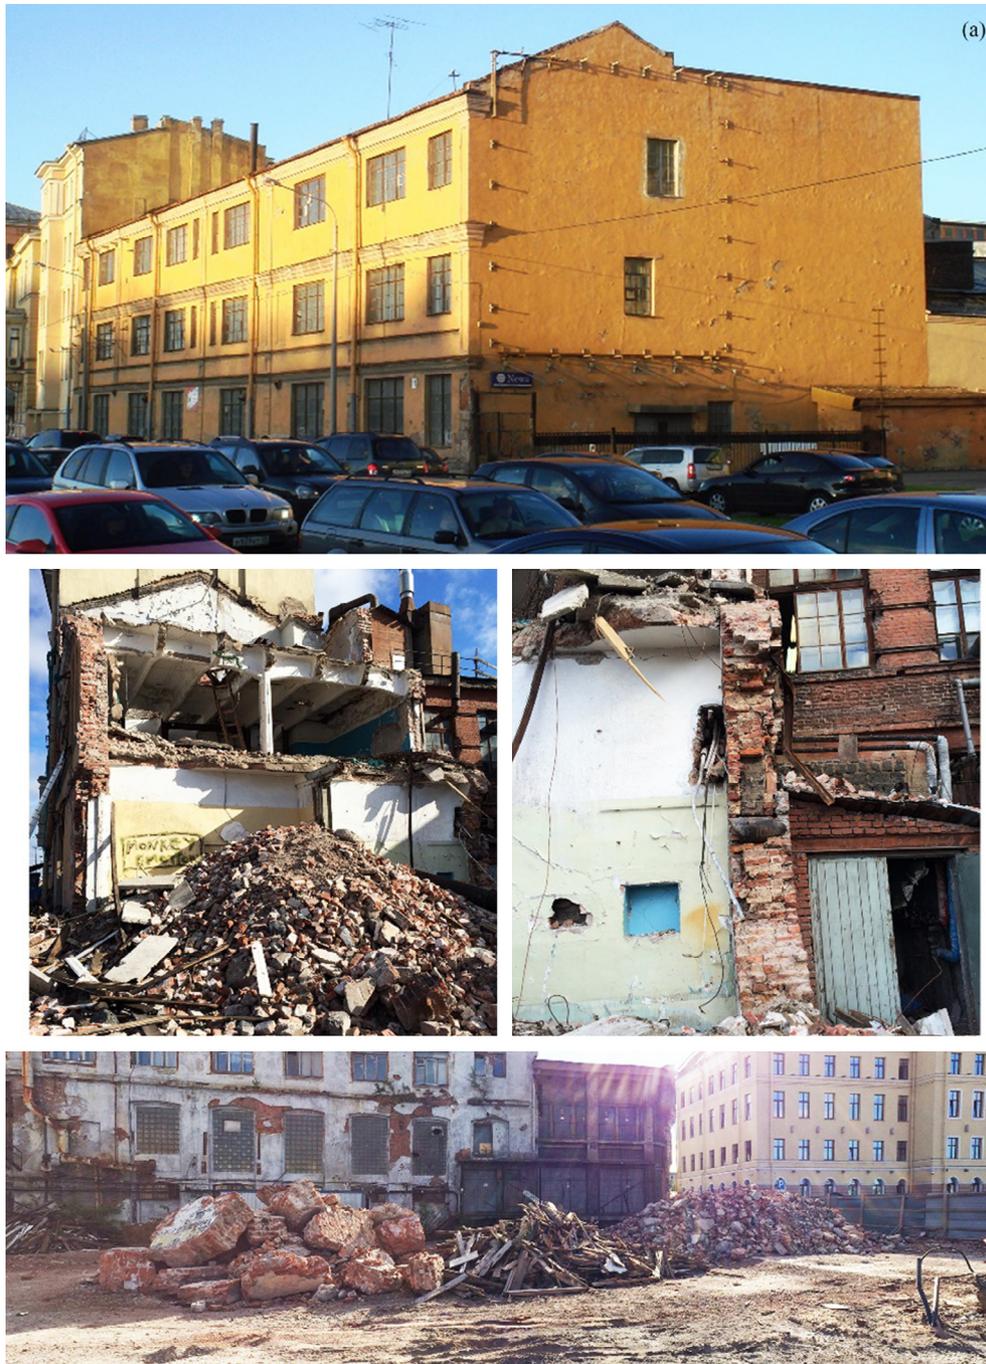
**Fig. 4.** Construction techniques and material of the building. (a) Citywalls, 2009 (the upper image only, the yellow building is from [7]).

The building was a three story high block with solid brick envelope and a gable steel roof (Fig. 4). Although the external walls were almost identical for the entire building, the construction techniques of the slabs, beams and columns differed from story to story. Use of different materials and techniques together in a single building was a common practice in many historical buildings in Russia especially in ones damaged buildings during the war, as well as the newly built ones belonging to the post-revolution and post-war era of economic crisis. Besides documentation of its architectural aspects, demolition process of the building was also observed and is presented in the following section.

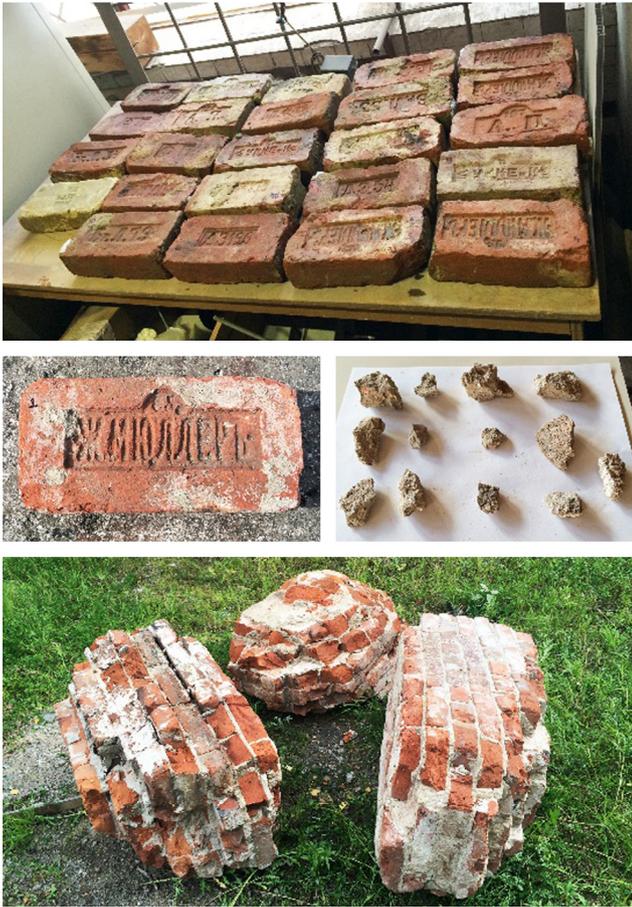
Fig. 5. Recovered brick, mortar samples and wall pieces.

A visual inspection of the demolition waste, which was composed of slightly deteriorated single bricks, mortar pieces and still intact masonry wall sections, was satisfactory with regard to its reusability (Fig. 5).

In order to analyze the inherent strength of the debris, three types of material, i.e. whole bricks, mortar fragments and wall sections (Fig. 5) were collected from the plot and brought to the Testing Laboratory of the Civil Engineering Institute of Peter the Great Saint-Petersburg Polytechnic University, in Russia. This laboratory has several testing facilities for the analysis of historical structures, including masonry walls.

dimensions of  $113 \times 63 \times 58$  cm ( $l \times w \times h$ ) and  $667 \text{ kg}^3$  were obtained from the site (Fig. 5). The 60 cm thick wall sections had traces of permanent plaster on the external surfaces while the internal surfaces were either plastered or their plaster had been stripped off later, during conversion of the space for other uses. The walls consisted of inner and outer layers of 12 cm thick brick with about 36 cm brick infill. The exposed walls had been constructed with English Bond<sup>4</sup> and although the outer and inner surfaces of the walls shared the same bonding pattern, one to one locational correspondence did not exist, i.e. the mortar line on one surface was not necessarily aligned with the other. Additionally, the infill was also of the same quality solid bricks as the ones used for the surfaces.

One wall section among the three illustrated in Fig. 5 was randomly selected for the preparation of a wall prism while the other two were allocated for further research. Strength test setups for wall prisms were not available in Russian standards. Therefore, the prisms were cut, shaped, capped and prepared according to ASTM C1532<sup>7</sup>. Professional judgement is used for choosing the less damaged part if the aim is to find the maximum strength; or the most damaged part if the aim is to find the minimum strength. Hence, from the point of view of possible reuse, it was more meaningful to select the pieces with the most damage. Therefore, samples close to the edges of the wall pieces were more suitable because of the greater damage due to the harsh impacts of demolition. Six samples were prepared as illustrated in Fig. 8. ASTM C1314<sup>8</sup> was used for cutting and dimensioning the samples; this standard is valid for both the recently built wall sections as well as extracted historical samples.

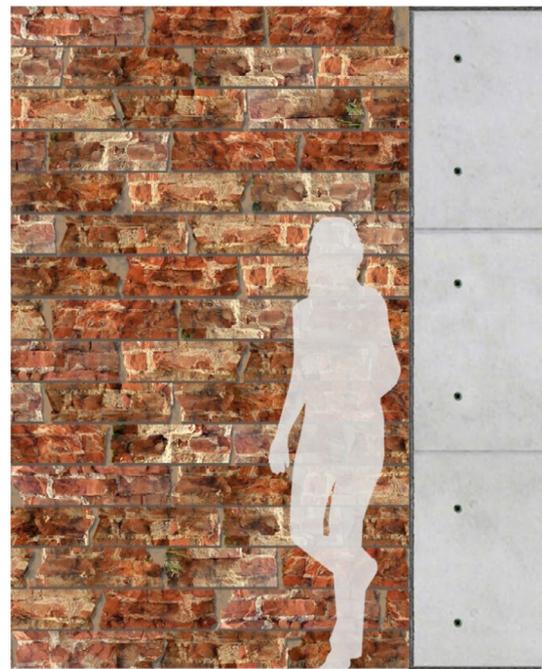
Fig. 6. Proposal for reusing the masonry wall sections.

Additionally, the broken wall pieces can be cut into smaller sections similar to ashlar masonry blocks (Fig. 6). These wall sections can be reused as secondary masonry units if old mortar can ensure the required integrity between the old bricks.

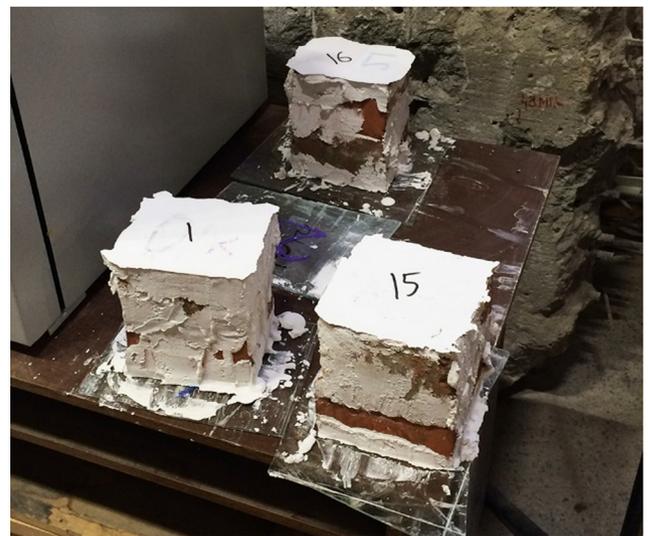
Fig. 7. Preparation of samples for physical property test and ready samples.

aside in case re-tests were required. 9 bricks were clean enough so no further cleaning was done before the flexural test. GOST 8462<sup>5</sup> recommends the application of flexural test prior to compression test, and therefore bricks were prepared accordingly. According to this standard, bricks that have been tested for their flexural strength are then cut into regular prisms that can be bonded together for further compression strength tests. Thus, the 3 bricks that had clean breaks and 3 non-tested bricks were cut into halves and the pieces were joined together with the help of conventional gypsum mortar (Fig. 7).

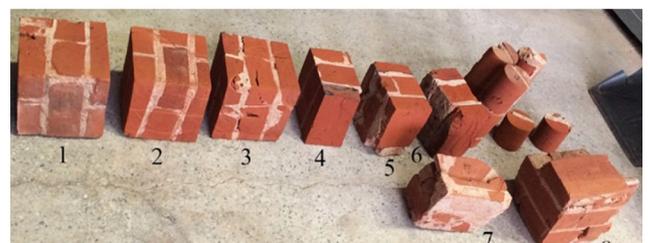
Fig. 8. Wall prism samples prepared for compression and shear tests (Sample #7 and #8 were broken during the cutting process, sample #2 is behind sample #3).

Three samples measuring 20 × 20 × 20 cm were prepared as wall prisms for compression test. Additionally, EN 1052-3<sup>10</sup> was used for the preparation of three samples with 20 × 10 × 20 cm (*l* × *w* × *h*) edges for shear test as illustrated in Fig. 8.

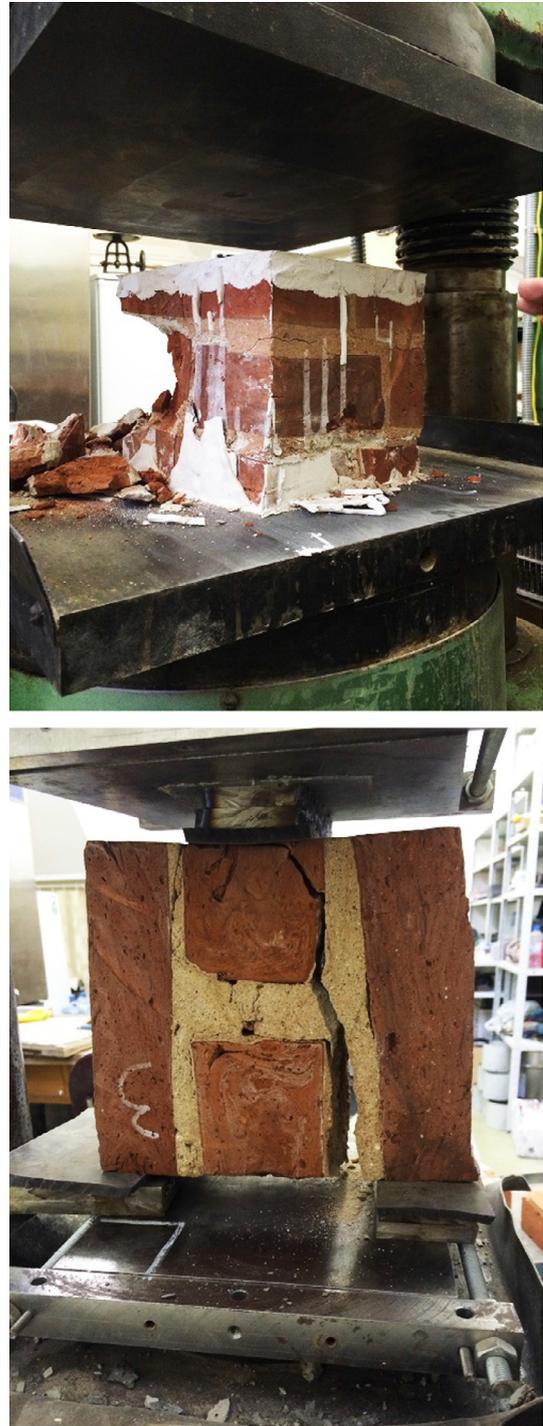
Fig. 9. Cracks during compression and shear tests.

The wall prisms for compression test were capped with gypsum mortar while the samples for shear test were not capped since the surfaces were suitable for the test setup (Fig. 9).

ASTM C1314<sup>8</sup> was used for the compression test of masonry prisms in accordance with their original load bearing direction as illustrated in Fig. 9. Eq. (5) was used for the calculation of actual strength and the results are given in Table 3.
